Assessment of Land Use Changes and Impacts of Dam Construction on the Mbaa River, Ikeduru, Nigeria

Original Research Article

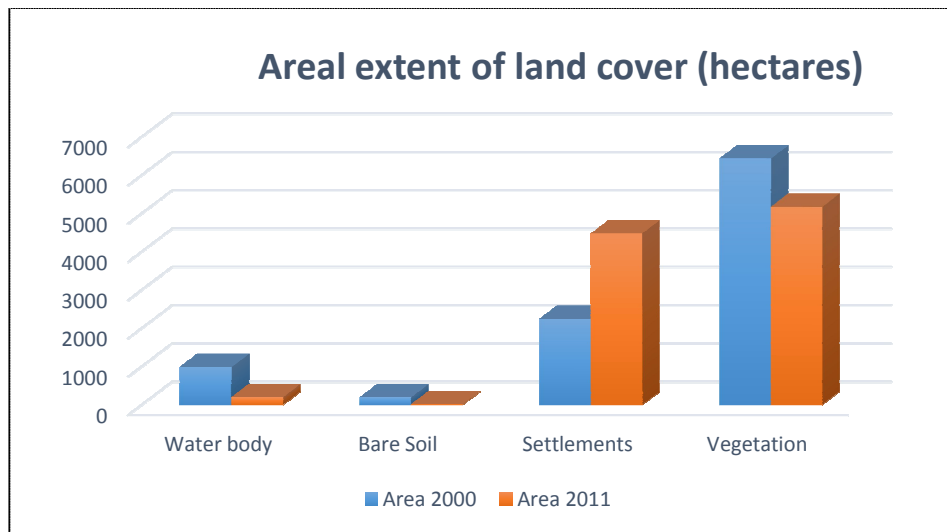
Fig. 4. Areal extent of land cover in hectares.

Fig. 4 and Table 4 shows that water bodies, bare soil and vegetation cover had negative change trends between 2000 and 2011 with -8.06%, -1.75% and -12.81% respectively indicating a decrease or loss in their area coverage. Whereas settlements had a positive trend with 22.62% indicating an increase or gain in its area

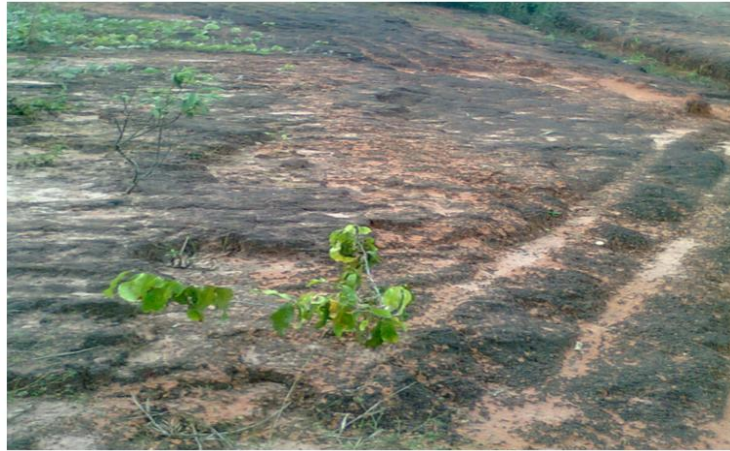
- 1) **Desiccation of Soil:** This may have resulted from the use of heavy duty trucks and other equipment during construction activities leading to compaction of soil and formation of hardpan as shown in Plate 1. It is in line with the submission of [6] that improper dam construction among other problems leads to decline in soil quality and fertility arising from water logging, salinization and hardpan formation.

Plate 1. Section of soil where a hardpan has been formed

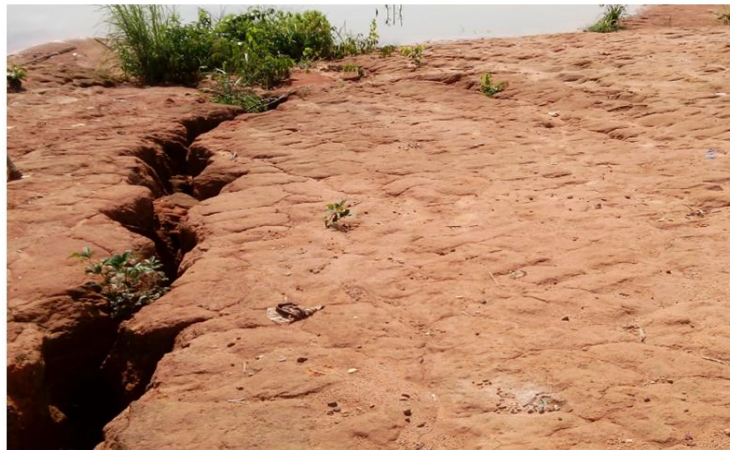
- 2) **Gully erosion:** Removal of vegetation cover as a result of dam construction was observed to result in the systematic removal of top layers of the soil and this has resulted in development of gully erosion within the watershed as shown in Plate 2 and agrees with the argument of [4] that dam construction leads to problems such as vegetation loss and soil erosion.

Plate 2. Gully erosion site at Mbaa River

economic life of the people thereby portending grave danger for food security as well as sustainable development. It becomes imperative therefore that relevant stakeholders in the constructed dam put up mechanisms and measures in place to mitigate the negative impacts of this dam. Such efforts should include land reclamation at the downstream sector, as well as proper utilization of impounded water for irrigation to boost dry season farming thereby compensating for lost farmland.

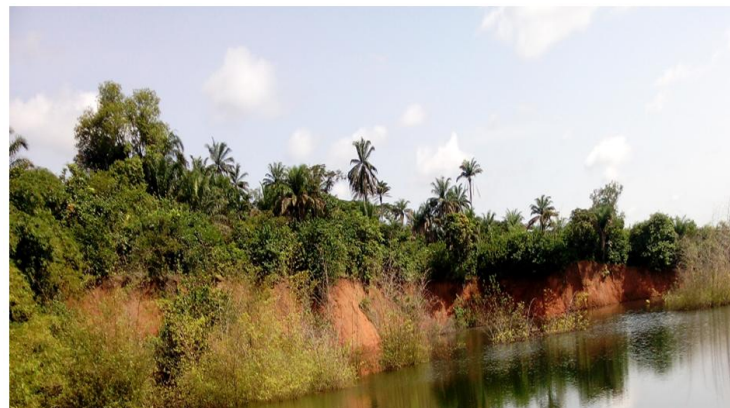
- 3) **Landslide:** There has been expansion of the upstream reservoir which has led to collapse of adjoining riverbank sand into the river, thus leading to further loss of agricultural land as evident in Plate 3.

Plate 3. Section of landslide at the river bank

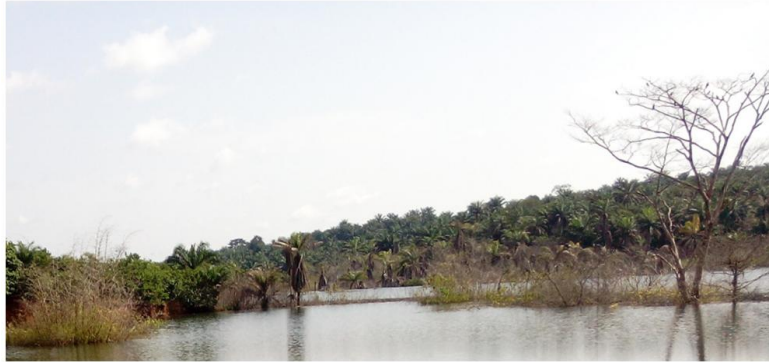
- 4) **Submergence of Agricultural Land:** There has been steady overflow of the reservoir upstream of the dam which has resulted in submergence of nearby farms leading to loss of agricultural land and decomposition of flooded vegetation as shown in Plate 4. This agrees with the submission of [14] vegetation in flooded areas. A situation that will cause soil deterioration and increase greenhouse gases emission while reducing stream flow and channel size downstream.

This situation could also have been largely responsible for the loss in area coverage of waterbody as area gained upstream may not be commensurate with area lost downstream and agrees with the submission of [15] that one of the

consequences of dam construction is the narrowing of stream channel downstream of the dam and subsequent invasion of the channel by vegetation.

Plate 4. Section of submerged agricultural land
