Investigating Soil and Water Contamination of Trace Metals in Tarkwa-Nsuaem Municipality, Ghana

Short Research Article

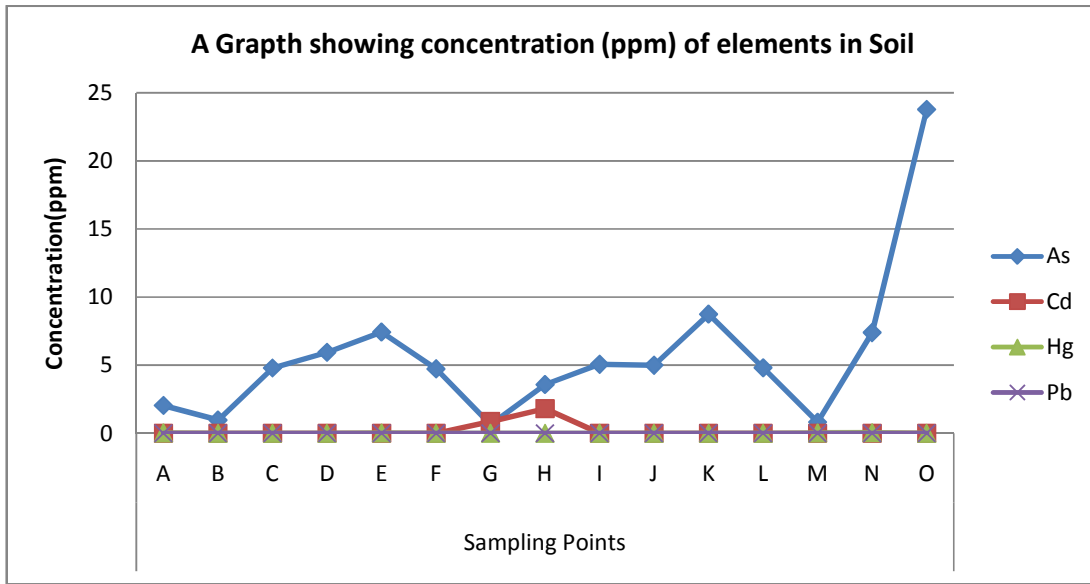
Fig. 2. A graph showing concentration (ppm) of elements in soil

The concentrations of arsenic, cadmium, mercury, and lead in µg/g for soil and mg/l for water as obtained from the laboratory analysis are shown in Figs. 2 and 3. The sampling points are represented with the letters A-O. In all cases Akoon was choosing as the control site and the remaining sites as experimental sites. All sampling sites were located at Tarkwa Nsuaem district.

A=Mile 8, B=Naboaso (Tarkwa), C=Post Office Sq.(Tarkwa), D=Tamso, E=Eduprien, F=Awunaben Basin, G=Akoon, H=Akyempim, I=Teberbie, J=Mile 9, K= New Atuabo, L=Mile 7, M=Bonsaso, N=Mile 10½, O=Old Town (Tarkwa).

Arsenic concentration in soil ranges from 0.65 µg/g to 23.78 µg/g (Fig. 2). The highest concentration was obtained at Old Town (Tarkwa). The least concentration of 0.65 µg/g was recorded at Akoon which was the control site and had no mining activity. The second highest concentration (8.75 µg/g) occurred at New Atuabo. New Atuabo and Old Town lie along the same geological plane with a steep slope and the fact that the two stations recorded high arsenic concentrations can be explained by the geology of the area and not the mining activity in the area. Arsenic level in soil increased from Tamso (5.95 µg/g) to Eduprien (7.44 µg/g); it then decreased from Teberbie (5.07 µg/g) to Mile 9 (5.00 µg/g), and further to 4.82 µg/g at Mile 7. However, the concentration fluctuated again to 7.40 µg/g at Mile 10½. The decrease trend may be due to geological factors whilst the sharp increase could be blamed on some anthropogenic factors. The IAEA-Soil-7 recommended value for arsenic concentration in soils is 13.50 µg/g. This implies that only the control site had arsenic levels below the IAEA guideline value. The high arsenic concentration recorded at Old Town can be blamed on the fact that the sampling point used to be a refuse dump hence; there could be some other anthropogenic introduction of arsenic into the soil besides mining.

The highest mercury concentration in soil (0.05 µg/g) occurred at Mile 10½. This was followed by Mile 8 which recorded 0.03 µg/g (Fig. 2). Nine stations including Akoon had mercury levels less than 0.01 µg/g. Stations where mercury was detected- Mile 10½, Mile 8, Eduprien, Teberbie and Bonsaso are places where galamsey operations are very common. The IAEA-Soil-7 recommended value for mercury level in soils is 0.04 µg/g. This means that all the stations have mercury levels within limits except Mile 10½

which had a concentration (0.05 $\mu\text{g/g}$) slightly above the recommended value. The sample was taken from a farmland. However, a critical observation of the trend of mercury occurrence in soils in the study area shows that mining activities, especially galamsey operations, play a significant role in mercury concentration in soils in the study area.

Cadmium level in soils at all the stations including Akoon was less than 0.01 $\mu\text{g/g}$ except at Akyempim which recorded 1.82 $\mu\text{g/g}$ (Fig. 2). The low concentrations could be due to geological factors. The IAEA-Soil-7 recommended value for cadmium concentration in soils is 1.30 $\mu\text{g/g}$. Akyempim had a concentration of 1.82 $\mu\text{g/g}$ which is above the IAEA guideline value and the control site of (0.86). This isolated case could be due to variations in the geochemistry of the place. Generally, it could be seen from the results that though these are typical mining areas, mining activities do not have any significant effect on soil cadmium levels in the study area.

Lead concentration in all the samples including that of Akoon was below 0.01 $\mu\text{g/g}$ (Fig. 2). The low concentration is probably due to the minute quantities in which lead minerals occur in the rocks of the area. The IAEA-Soil-7 recommended

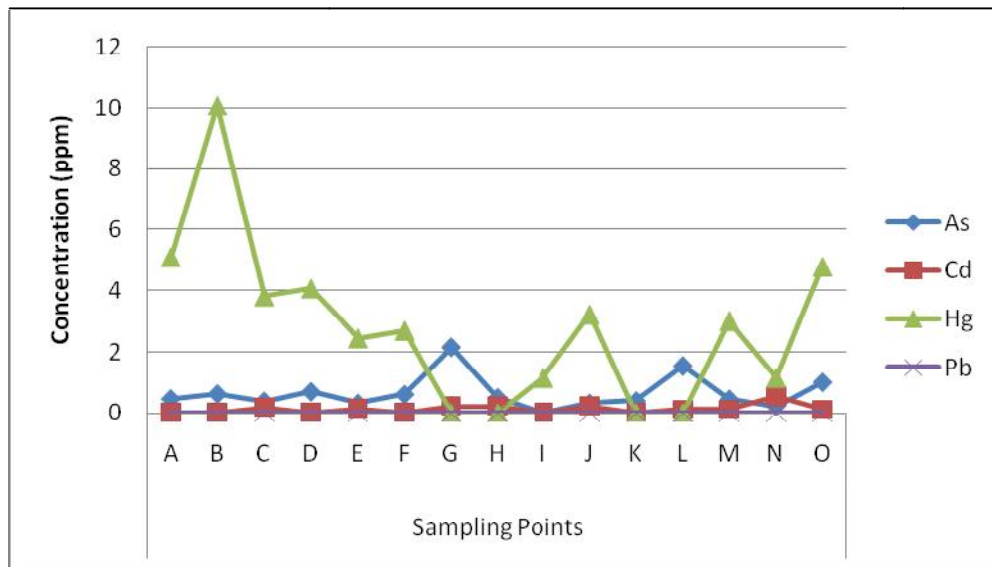
Fig. 3. A graph showing concentration (ppm) of elements in water

A=Mile 8 (borehole), B=Akyempim (Well), C=Mile 10½ (stream), D=Tamso (bore hole), E=Eduprien (pond), F=Mile 8 (stream), G=Teberbie (borehole), H=Akyempim (stream), I=Akoon (borehole), J=Mile 9 (well), K=New Atuabo (borehole), L=Mile 7 (borehole), M=Bonsaso (River Bonsa), N=Mile 10½ (borehole), O=New Atuabo (well).

Concentration of Arsenic at the 15 sampling points ranges from <0.01 mg/l to 2.14 mg/l (Fig. 3). The highest concentration, 2.14 mg/l was recorded at Teberebie (bore hole) and the lowest concentration of less than 0.01 mg/l was recorded at Akoon (bore hole). Concentration of as in ground water declines from Tamso (0.70 mg/l) to Akyempim (0.63 mg/l), and to Mile 8 (0.47 mg/l); then finally, to Mile 9 (0.32 mg/l). Given the fact that Mile 10½ recorded a concentration of 0.22 mg/l, the sequential decline in concentration could be due to geological factors. However, Mile 7 which is located between Akyempim and Mile 8 recorded a higher arsenic level of 1.54 mg/l. This gives a strong suspicion of an anthropogenic cause such as mining. Furthermore, streams sampled at

Mercury concentration as observed from Fig. 3 ranges from <0.01 mg/l to 10.07 mg/l. The highest concentration (10.07 mg/l) occurred at Akyempim in a well. The second highest concentration was 5.09 mg/l, and this was recorded at Mile 8 in a bore hole; followed by New Atuabo which recorded a concentration of 4.78 mg/l also in a well. Concentrations less than 0.01 mg/l being the lowest occurred at Akoon, Mile 7, and New Atuabo, all in bore holes. This suggests that bore holes at these stations are quite safe for consumption. The disparity in mercury concentration between the well and the

Six stations including Akoon out of the fifteen, have cadmium concentrations below the detection limit (<0.01 mg/l), suggesting that cadmium is either completely absent in the samples or the concentrations are extremely low. The highest concentration was 0.55 mg/l recorded at Mile 10½ while the least recorded concentration was 0.11 mg/l, occurring concurrently at Mile 7, New Atuabo, and Bonsaso (Fig. 3). The WHO guideline value for cadmium in drinking water is 0.003 mg/l [16]. This means that all the stations where Cd was

Laboratory analysis for lead in the 15 samples including Akoon taken from various locations within the study area was very low (Fig. 3). Not a single station had Pb concentrations equal to or above 0.01 mg/l which is the WHO guideline value, and of course, the detection limit of the equipment used. This implies that either Pb is completely non-existent in the samples or the concentrations are extremely low.
